Lotus Elan M100 Service Bulletins  
Series 1 and Series 2 1990 - 1996

# SERVICE BULLETIN

1990/11

**TITLE:** Replacement of headlamp flap 'J' links.**REASON:** Incorrect material specification of some links may result in distortion of link and faulty operation of headlamp mechanism.**ACTION:** At the next opportunity (i.e. next time the vehicle is on the dealer premises), replace the headlamp flap 'J' links on all 1990 model year Elan and Elan S.E. models in the following VIN range:VIN serial number 6105 to 6192 inclusive.  
Check VIN of all dealer stock and demonstrators.**Parts Required**

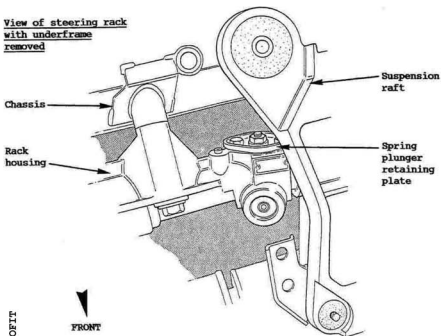
View of steering rack  
with underframe  
removed

- TITLE:** Replacement of steering rack spring plunger.
- REASON:** Material specification improvement for extended durability.
- ACTION:** At the next opportunity, (i.e. next time the vehicle is on the dealer premises) replace the steering rack plunger on all 1990 model year Elan and Elan S.E. models, manual and PAS, in the following VIN range:

To replace the plunger, proceed as follows:

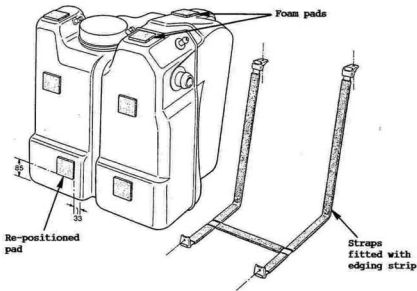
**TITLE:** Replacement of fuel tank.

**REASON:** Revised moulding with improved resistance to joint line leakage.

8. Release the locknut from the underside of the two strap top fixing bolts, and unscrew each bolt. Swing down the two straps and carefully lower the tank, easing the filler stub through the body.
9. Transfer the balance pipe to the new tank, but leave one end disconnected.
10. Use Silastic RTV 732 adhesive (A036E6038) to secure the seven foam rubber pads to the new tank in the positions shown on the diagram. Note that all the positions except the RH lower position on the tank front face are indicated by moulded corner lines on the tank.

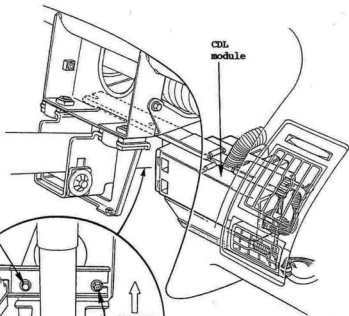
**TITLE:** Identification and replacement of early CDL module.

**REASON:** Specification improvement.  
Some early cars, fitted with the 'A' level CDL module can, under certain conditions, require the manual unlocking of the passenger door to regain full CDL operation.

1. Release the CDL unit mounting bracket from the steering column brace: Slacken the nut at the left hand side of the column, and remove the setscrew from the right hand side of the column and withdraw the bracket and module/relay boxes into the footwell.
2. Unplug the electrical connector from the CDL module, and remove the two screws securing the module to the mounting bracket.
3. Fit the new module to the mounting bracket, with the lugs on the module correctly located beneath the lip on the bracket. Retain with the two fixing screws. Plug in the electrical connector.
4. Refit the bracket to the column brace, with the flat and spring washers.

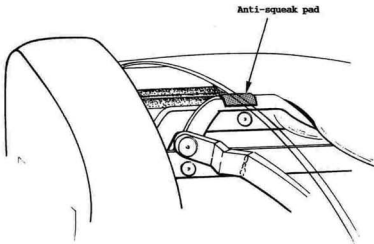
**REASON:** To prevent squeaking noises caused by contact between front edge of roof stowage lid and soft top support frame.

**ACTION:** If a squeaking noise on an Elan is found to be caused by the front lip of the roof stowage lid rubbing on the soft top support linkage, a self adhesive anti-squeak pad should be applied to each 'C' link as detailed below:

- At each side of the car, thoroughly clean the top surface of the 'C' link immediately below the front edge of the roof stowage lid, and mark the point of contact.
- Peel off the backing strip and stick a pad onto the roof link centrally about each contact point.

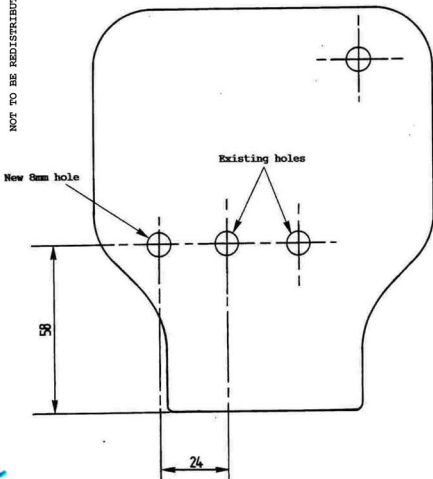
**TUNNEL TRAY TEMPLATE**

**REASON:** Due to recent clarification of international legislation on permitted microwave frequencies and power outputs, the Gemini '1059' microwave sensor supplied with Lotus Elan Vehicle Alarm System kits, is to be replaced by a revised version which uses a different frequency and also incorporates improved sensitivity adjustment control.

1. Remove the mat from the parking brake lever recess, and by referring to the attached template, check whether the modification has already been carried out, as indicated by the presence of the additional (offset) hole for the microwave sensor LED. If the sensor is found to be fitted in the new offset position, take no further action.
