MISDIAGNOSING A DISTRIBUTORLESS IGNITION SYSTEM

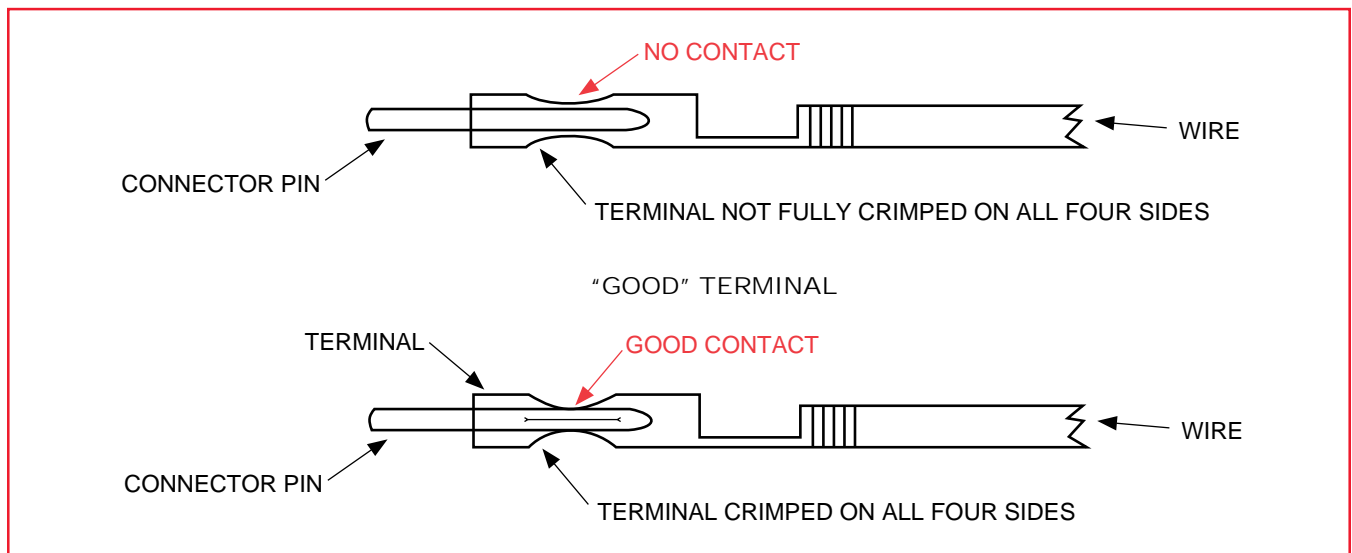
FIG. 2

The integrity of the connections should always be a concern when diagnosing an intermittent no-start condition. The connectors may be secured in their latches, but the terminals may not be making

electrical contact (see Fig. 2). Visually examine the connectors and test their integrity with the proper pin gauge or a mating terminal. Do not use a paper clip or similar object as terminal damage will occur. The gauge or terminal should not pass freely through the female terminal. If the female terminal does not grip properly, replace it. Bending or crimping the female terminal is usually a temporary fix.

GM addressed this concern in Service Bulletin 88-6E-18. Some vehicles may experience an intermittent no-start condition ("Cranks But Won't Run"), due to an intermittent electrical connection between DIS module and crankshaft sensor. The no-start is most likely to occur when the engine is cold.

Examination of their warranty material has shown that the connection problem was being improperly diagnosed as a DIS module condition, resulting in repeated come-backs and customer dissatisfaction. Because the integrity of the connection between the module and crankshaft sensor is provided by the terminal design, replacing the DIS module will not provide a lasting fix for the intermittent condition.
