Lotus Elan M100 Service Bulletins  
Series 1 and Series 2 1990 - 1996

# SERVICE BULLETIN

1990/11

**TITLE:** Replacement of headlamp flap 'J' links.**REASON:** Incorrect material specification of some links may result in distortion of link and faulty operation of headlamp mechanism.**ACTION:** At the next opportunity (i.e. next time the vehicle is on the dealer premises), replace the headlamp flap 'J' links on all 1990 model year Elan and Elan S.E. models in the following VIN range:VIN serial number 6105 to 6192 inclusive.  
Check VIN of all dealer stock and demonstrators.**Parts Required**

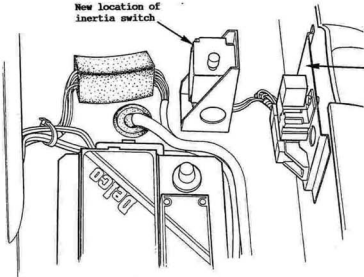
New location of inertia switch

Previous location of inertia switch

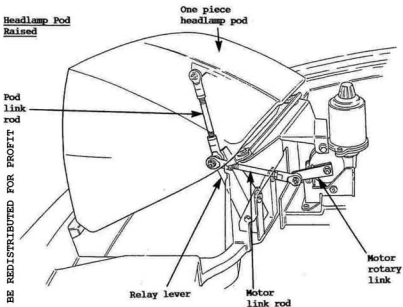
Headlamp Pod  
Raised

Operation: When the headlamps are switched on, the headlamp motor operates and the rotary link moves forwards until it contacts the upstop, when the motor stalls and switches off. In the up position, the pod link and the relay lever form an almost straight load path to hold the pod steady. Electrical control is similar to the previous system except that:
