MISDIAGNOSING A DISTRIBUTORLESS IGNITION SYSTEM

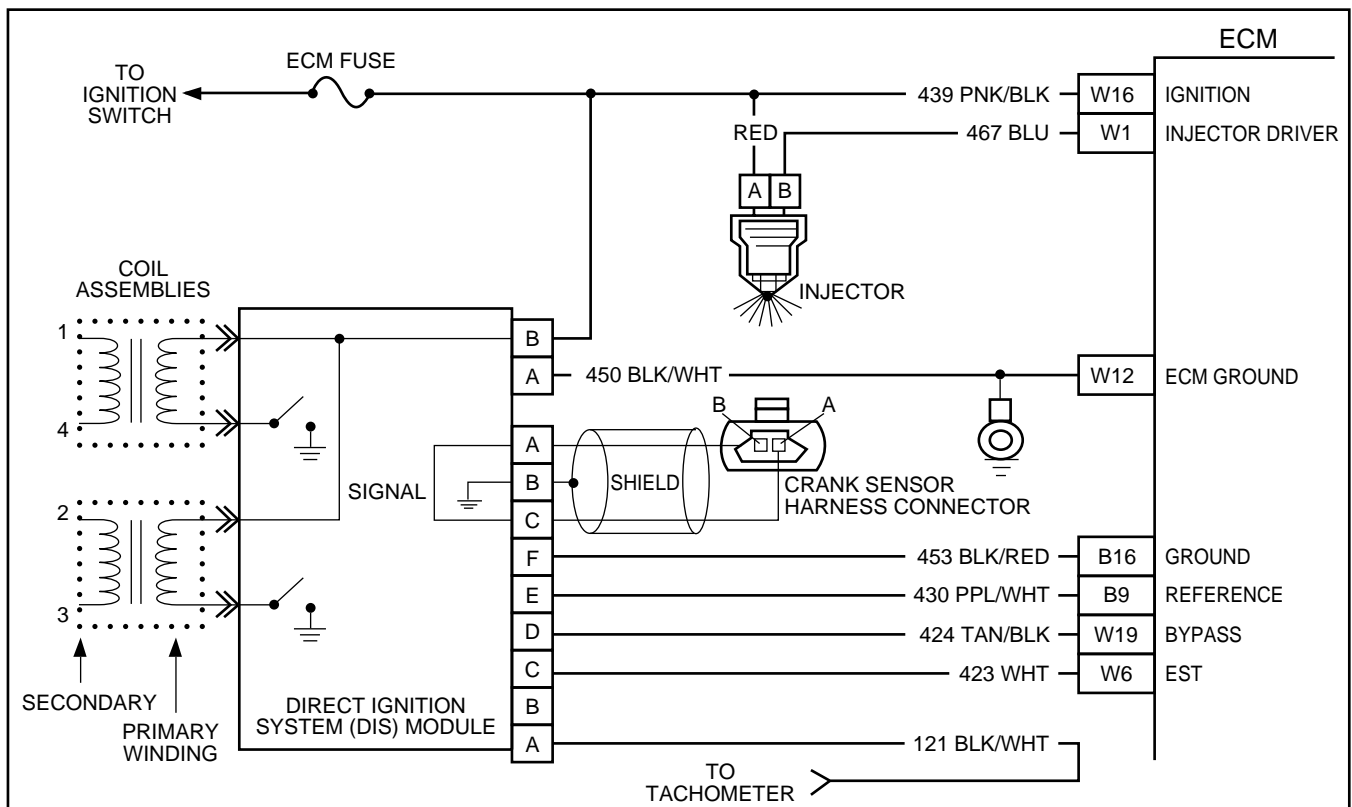
FIG. 1

The DIS System consists of 2 or 3 separate ignition coils, an ignition module, a crankshaft sensor, a network of wiring and the Electronic Spark Timing Circuit within the Electronic Control Module (see Fig. 1). Precise and consistent signal inputs are imperative or a no-start condition is inevitable. The DIS System must distinguish between crankshaft sensor signals and other signal noises such as Radio Frequency Interference. This requirement means the module waits for specific voltage signals before
